PRESS INFORMATION

Ceiling demolition - bunker demolished inside a building

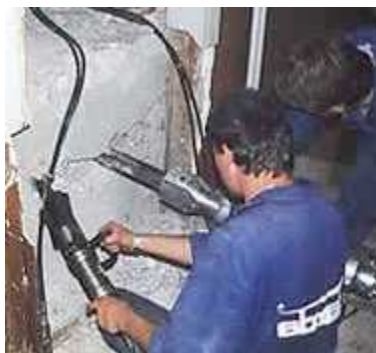
The work was conducted from the floor above the shelter. First, the requisite holes were drilled with a DR 086 mini drill rig. This was mounted to a small Brokk 150 demolition robot. Following this, a single C 12 N splitting cylinder was used to demolish the hard, uppermost layer of concrete (about 45 cm thick). Powered by an electric EP-type hydraulic unit, it produces the minimum of noise, dust and vibrations. It proved possible to remove the next, softer layer with a hydraulic breaker, also mounted to the Brokk 150 robot. The third, hard layer was demolished in turn with the C 12 N splitting cylinder and EP power unit. Given the specified conditions, it would not have been possible to demolish the shelter ceiling without a hydraulic rock and concrete splitter.
